# Implanted Ports: Skin Erosion

*Dawn Camp-Sorrell, MSN, FNP, AOCN®*

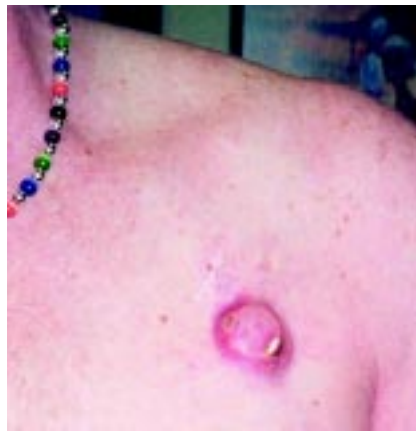
Ms. J is a 52-year-old female who had a left hemicolectomy with node dissection for stage III colon carcinoma. The primary tumor was 3 cm in diameter with invasion through the bowel wall into the mesenteric fat. Ms. J was offered adjunct chemotherapy with weekly 5-fluorouracil and leucovorin for a total of 48 weeks. An implanted port was placed in the subclavicular area of the anterior chest wall to administer chemotherapy. Ms. J tolerated the chemotherapy without untoward effects until she presented to the clinic for her 32nd treatment. As the nurse observed the port site, she noticed that a portion of the port edge eroded through the skin (see Figure 1). The area appeared slightly erythematous but without drainage or edema. The patient exhibited no systemic signs of infection. Because the portal body had eroded through the skin, peripheral access was obtained to administer the chemotherapy and the port subsequently was removed. Fortunately, Ms. J did not experience an infection in the port pocket from the skin erosion.

**FIGURE 1. SKIN EROSION WITH AN IMPLANTED PORT**

A potential complication of implanted ports is the erosion of skin with extrusion of the portal body. Erosion can occur within days after port implantation if the incision site overlies the port septum and wound dehiscence occurs (Beheshti et al., 1998). Erosion can develop over time when the port septum is accessed at the same location each time, causing the skin to focally erode (Whitman, 1996). Erosion can result from the loss of viable tissue over the implantation site exposing the portal body (Camp-Sorrell, 1992). The loss of viable tissue also can occur if the patient has lost a substantial amount of weight (Camp-Sorrell, 1992). Implanted ports that are placed just under the skin surface in active patients are vulnerable to repetitive movement that may

cause the overlying skin to erode. Ethyl chloride spray, when used as a topical anesthetic to access the port on a weekly basis, can be a cause of skin breakdown. Frostbite or skin ulceration are untoward effects of using this spray frequently (Moureau & Zonderman, 2000). Erosion also can develop because of poor wound healing of the port insertion site, especially if the incision overlies the portal septum (Whitman). Erosion of the skin usually is a gradual process that can permit bacteria to become trapped in the port pocket. As a result of skin erosion, a scab can form that allows microorganisms to enter the port pocket, which causes a port pocket infection.
